# Insec(tc)ure\*:

A UT Urban IPM Lab Newsletter for the Pest Management Industry

### An Unusual Infestation of Millipedes

Karen Vail, UT Entomology & Plant Pathology

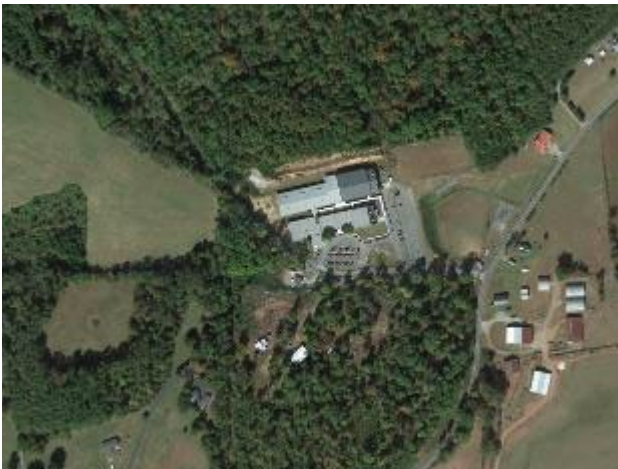
Figure 1. A rural Tennessee school surrounded by forest on three and a half sides. To the east is a septic drain field and parking lot.

Let me give you a tour of what we encountered during a site visit. The school was surrounded by forest on three and a half sides. On the northeast side was a septic drain field, and to the east, a parking lot (Figure 1). Tree leaves and needles in these forests could retain moisture on the ground and provide a source of decaying organic matter for these arthropods to feed. So right away, we were concerned.

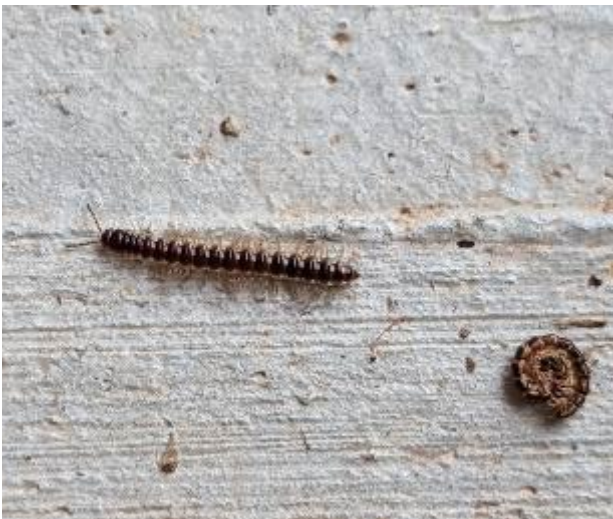
We started walking around the school's perimeter on our way to the gym in the northeast corner. It didn't take long for us to encounter the first of many *Oxidus gracilis* (C. L. Koch), commonly called a garden, greenhouse, hothouse or short-flange millipede (Figure 2). We saw millipedes just about everywhere we looked. Occasionally we would stop to take a photo (Figure 3).

Figure 2. The millipedes found at this school were *Oxidus gracilis* (C. Koch), a common invasive species.

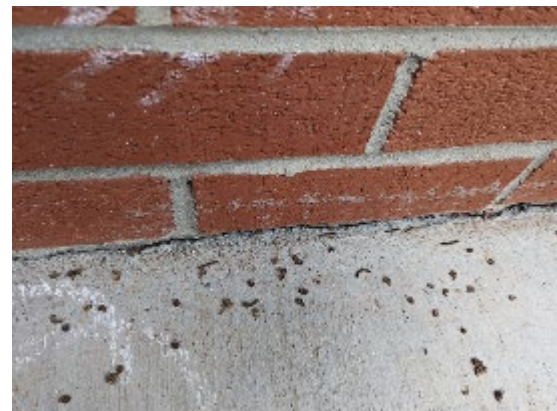
Figure 3. Dead millipedes from insecticide applications to the exterior perimeter.

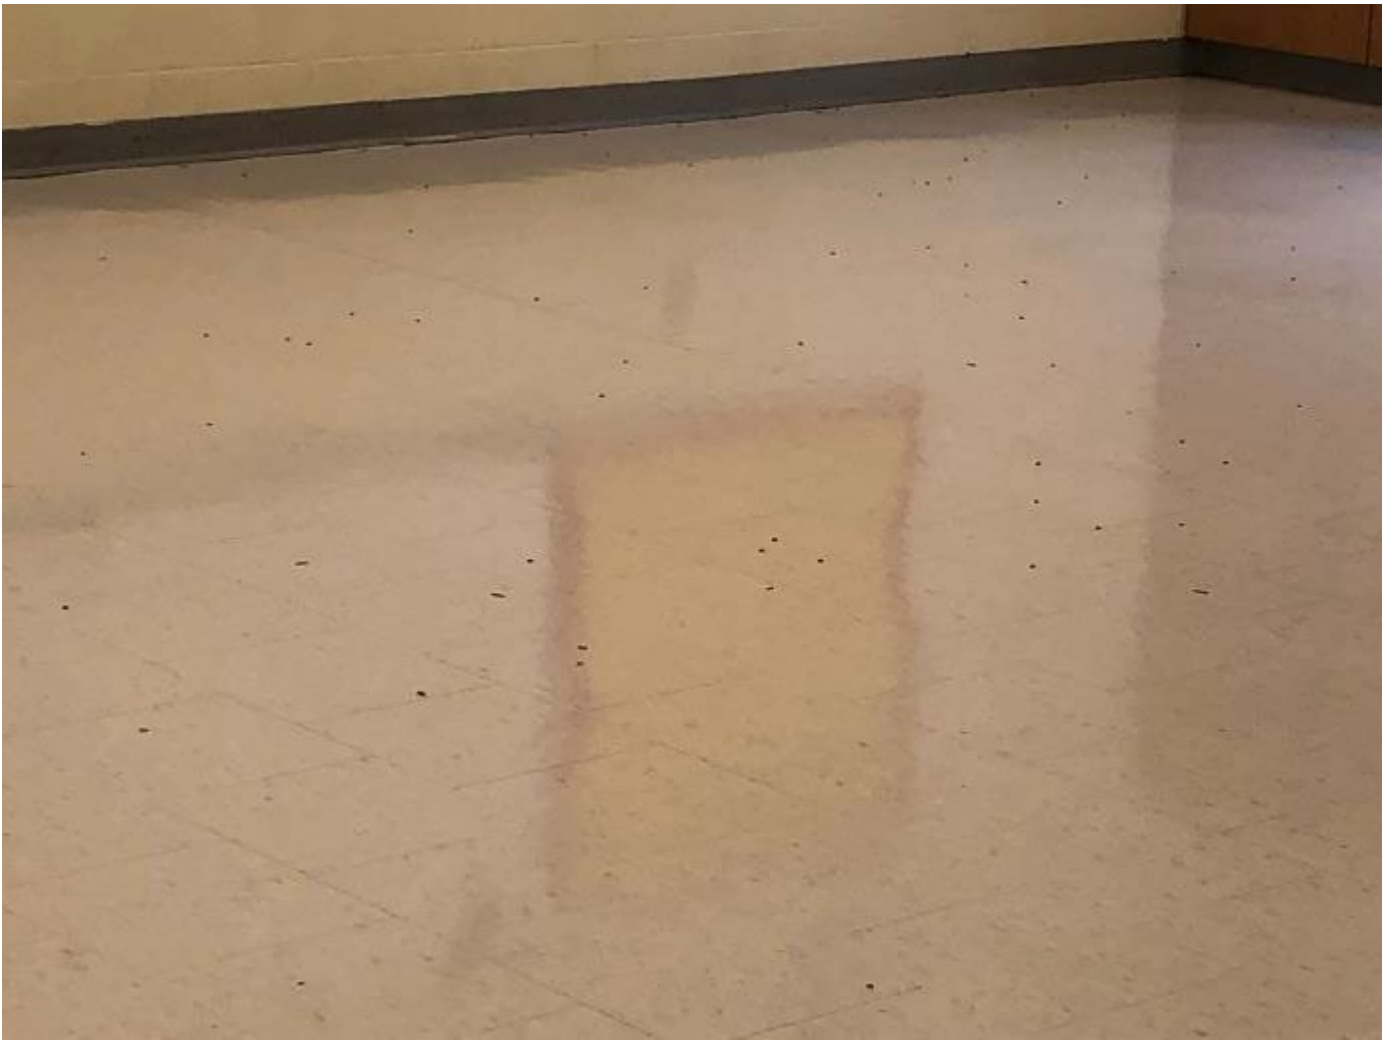
*Figure 4. Living and dead millipedes scattered across the interior of a classroom.*

We reached the gym to find it being used, but still found many millipedes scattered about. Figure 4 shows an example of these pests scattered over a classroom floor.

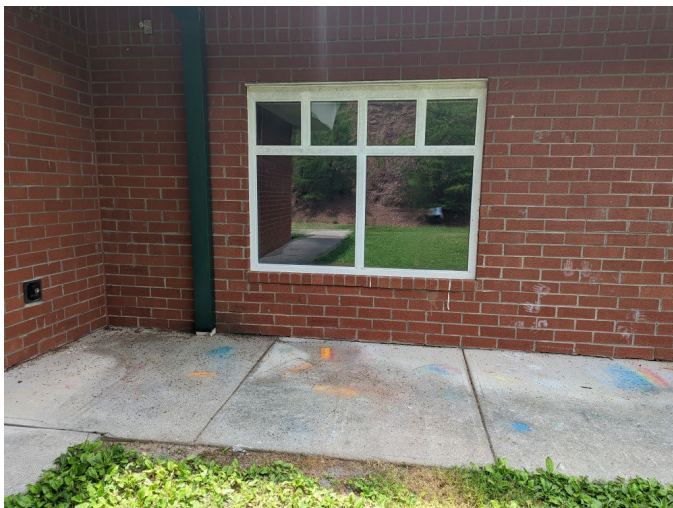
*Figure 5. Chalk art drew us to this section, but it wasn't the main attraction.*

The more we explored, the more we discovered this place was a paradise for millipedes. As we continued our inspection, we saw chalk on the sidewalk and set out to observe the artwork (Figure 5). However, we very quickly noted the art was not our main attraction; a tremendous number of millipedes were enjoying the art too (Figure 6).

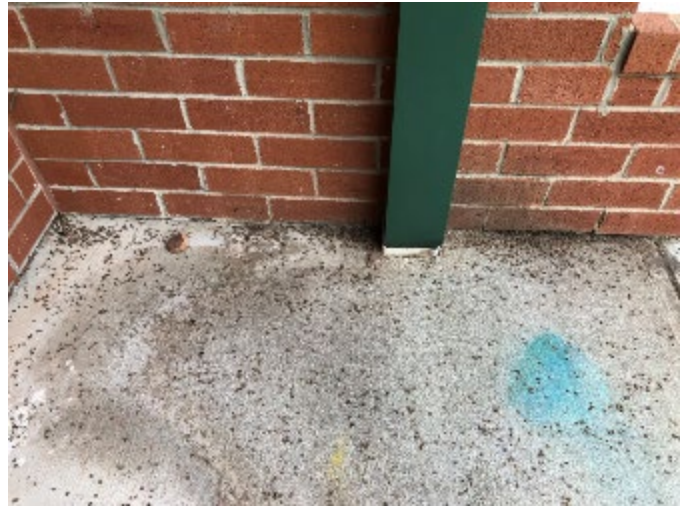
*Figure 6. A tremendous number of millipedes were found in this corner close to the downspout.*

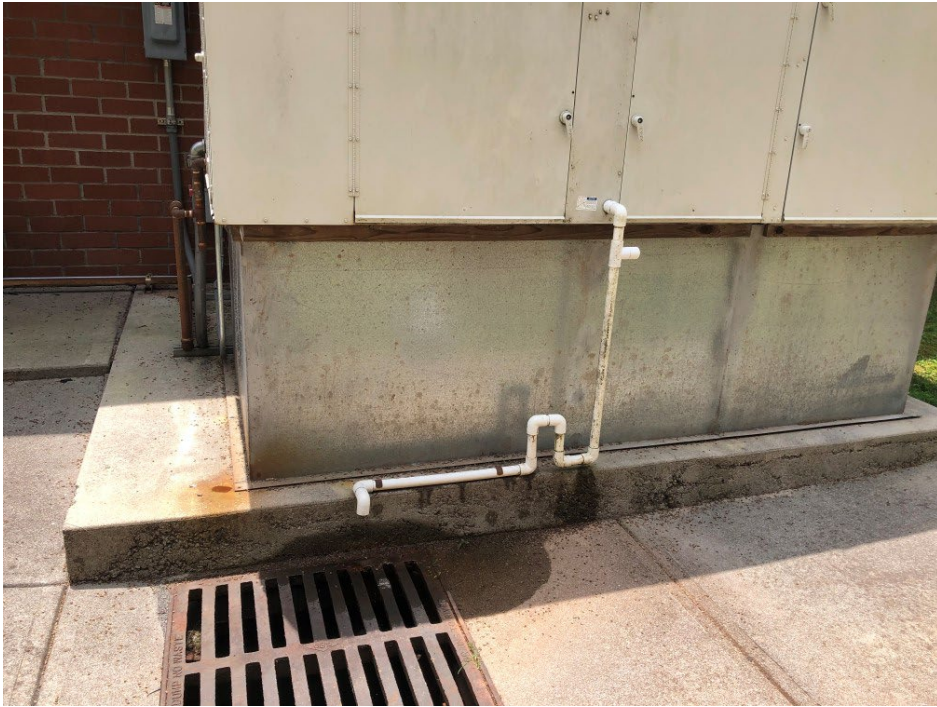
*Figure 7. Condensation from the AC unit is led to the drain.*

Moisture sources were abundant at this school. Drain pipes ran through the area behind the school. That is, between the school and a steep red shale bank. Condensation from the AC unit emptied into a drain (Figure 7) and sure enough, millipedes were enjoying this area too (Figure 8). Observation through a drain covering in the grass (Figure 9) yielded the same result of numerous millipedes, but this time they were alive (Figure 10).

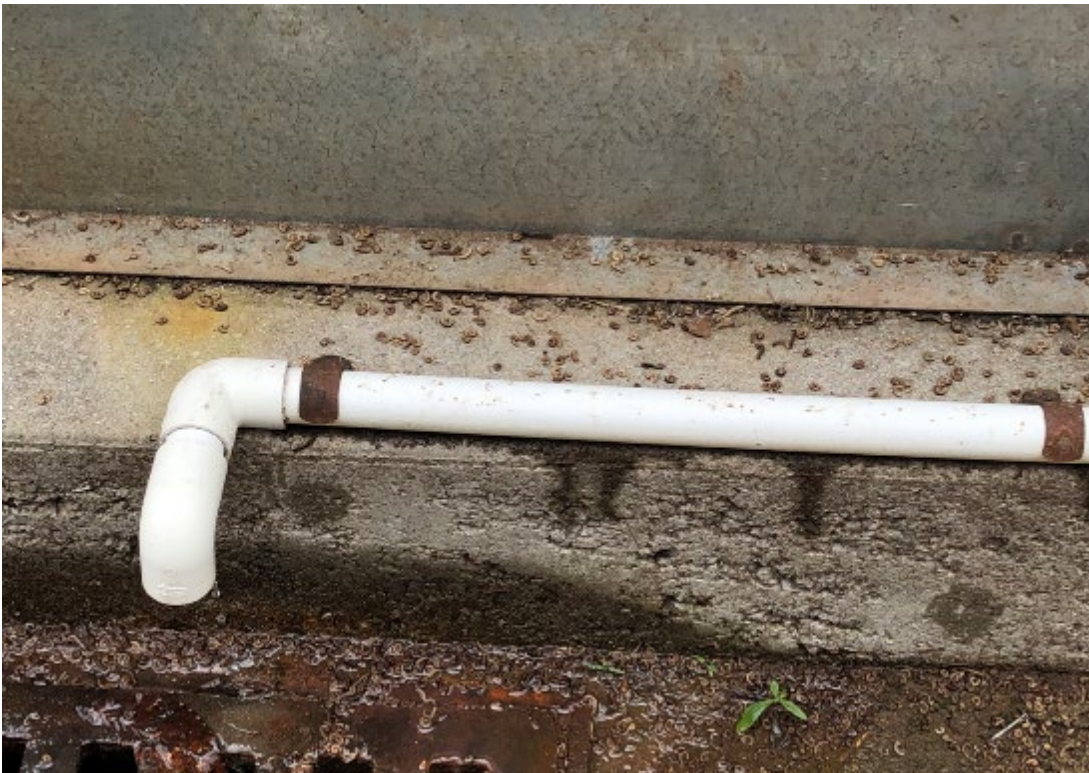
*Figure 8. Upon closer inspection, millipedes were also abundant here.*

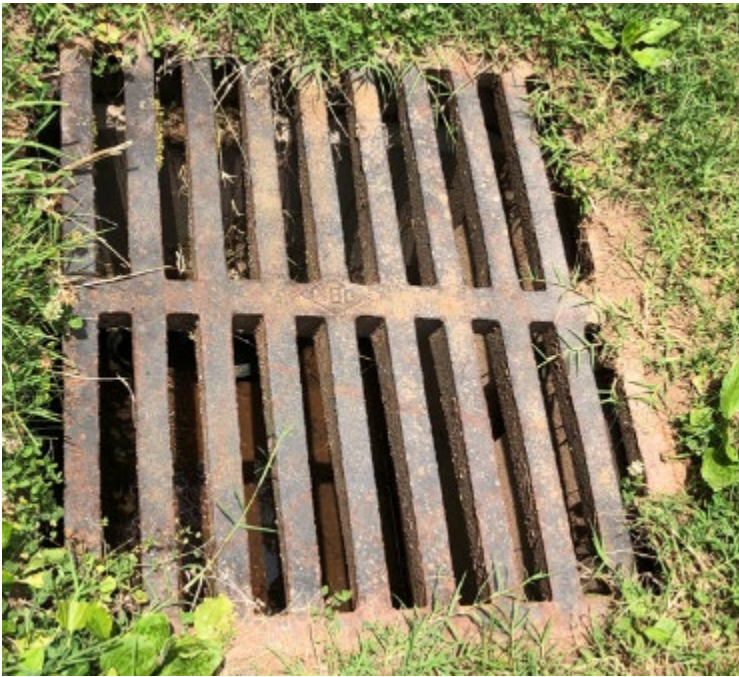
Figure 9. The drainage system runs through the grass on the north side of the school and before the red shale bank.

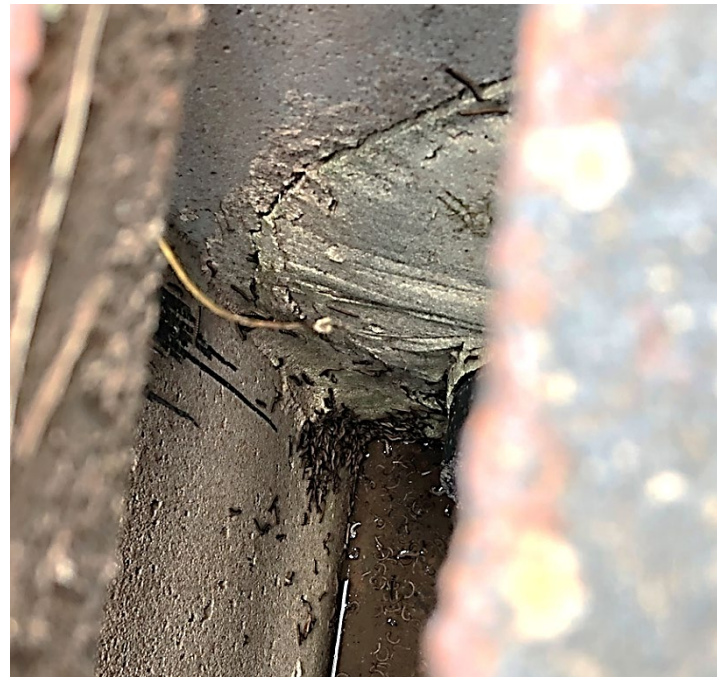
Figure 10. Peeking between the drain slats we noticed a clump of living millipedes.

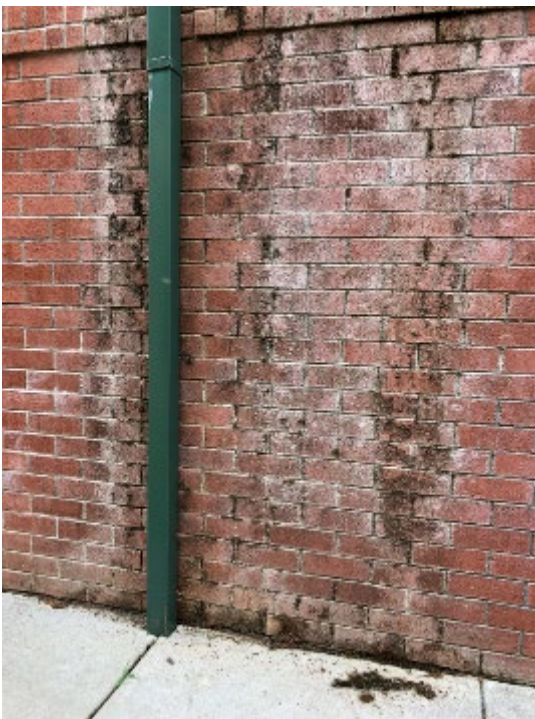
Figure 11. Moss growing on the exterior of the building was probably due to a prior drainage system or damaged roof.

We were impressed with the downspouts and the drainage system at this school. We typically find downspouts stopping before ground level and leaving draining water to create giant puddles below, concerning us about mosquito larvae living in the puddle, or springtails, millipedes, and pillbugs feeding on the moist, decaying matter that follows. However, these downspouts were in reasonably good shape and appeared to lead neatly into an underground drainage system. Moss growing on the side of this building (Figure 11) indicates moisture problems above. The millipedes were abundant here too (Figure 12).

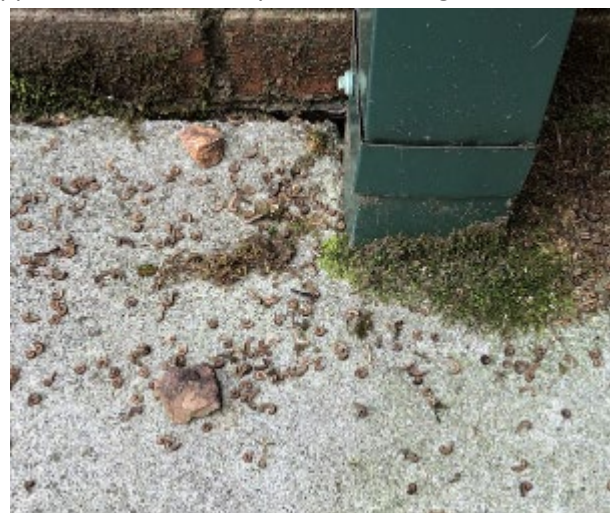
Figure 12. Millipedes were abundant at the base of this downspout too.

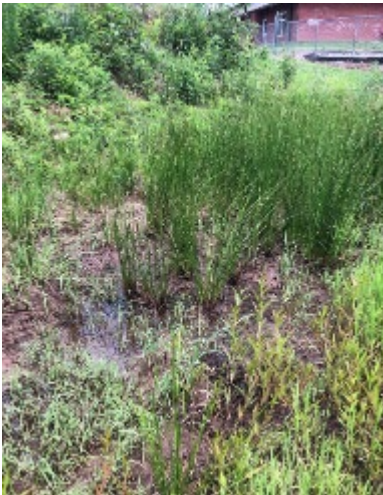
As we made our way around the school, we noticed a few more areas possibly conducive to millipedes. Northwest of the school, I'm uncertain if it's on their property or not, we noted a small wet area (Figure 13). Sure enough, we lifted a board sitting on the ground (Figure 14), and found an abundance of thriving millipedes (Figure 15). But the story doesn't end there.

Figure 13. A small wet area on the northwest corner of the school.

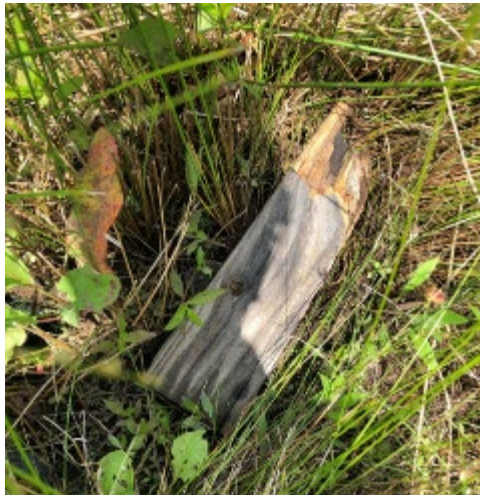
Figure 14. A board sitting on the ground in the wet area.

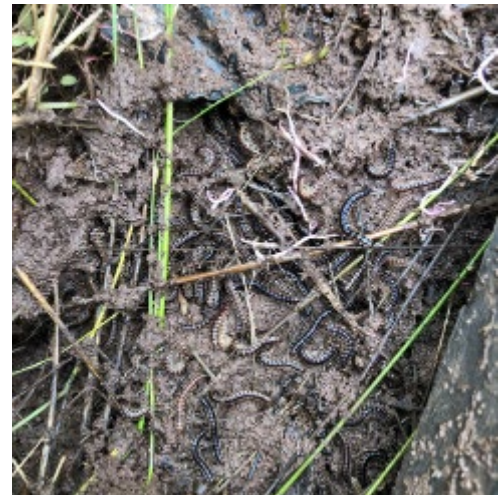
Figure 15. An abundance of millipedes living under the board in Figure 14.

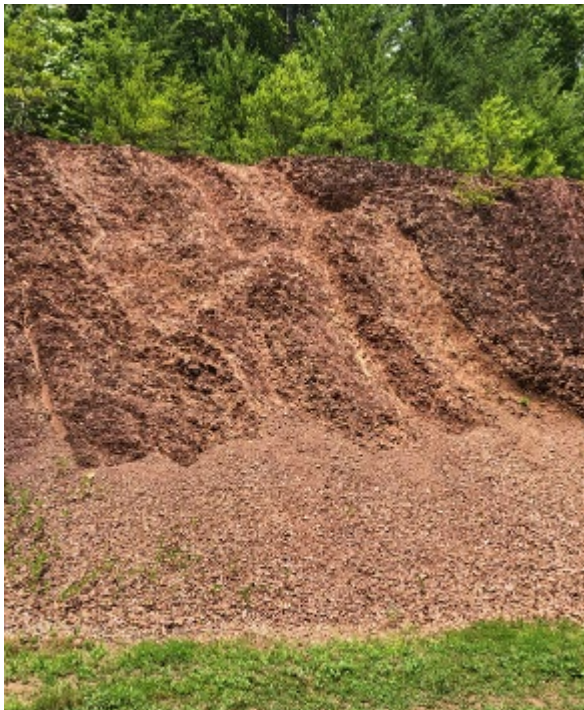
If you look at the image in Figure 1, note the bare area on the north side of the school. That's a steep bank of red shale (Figure 16). The many cracks and crevices in this bank could provide harborage for millipedes. Poking around in a shady part of this bank led us to a scorpion, probably *Vaejovis carolinianus* (Beauvois), the southern unstriped scorpion also called the southern sun devil. We brought it and some of the rocks and soil, along with a few millipedes, back to the lab to observe interactions between the two. We were surprised that our scorpion was a female - the young we later found on her back led us to this discovery (Figure 17).

Figure 16. A steep red shale bank with many cracks and crevices for millipedes to hide, runs the entire north side of the school about 20 - 40 feet from the building.

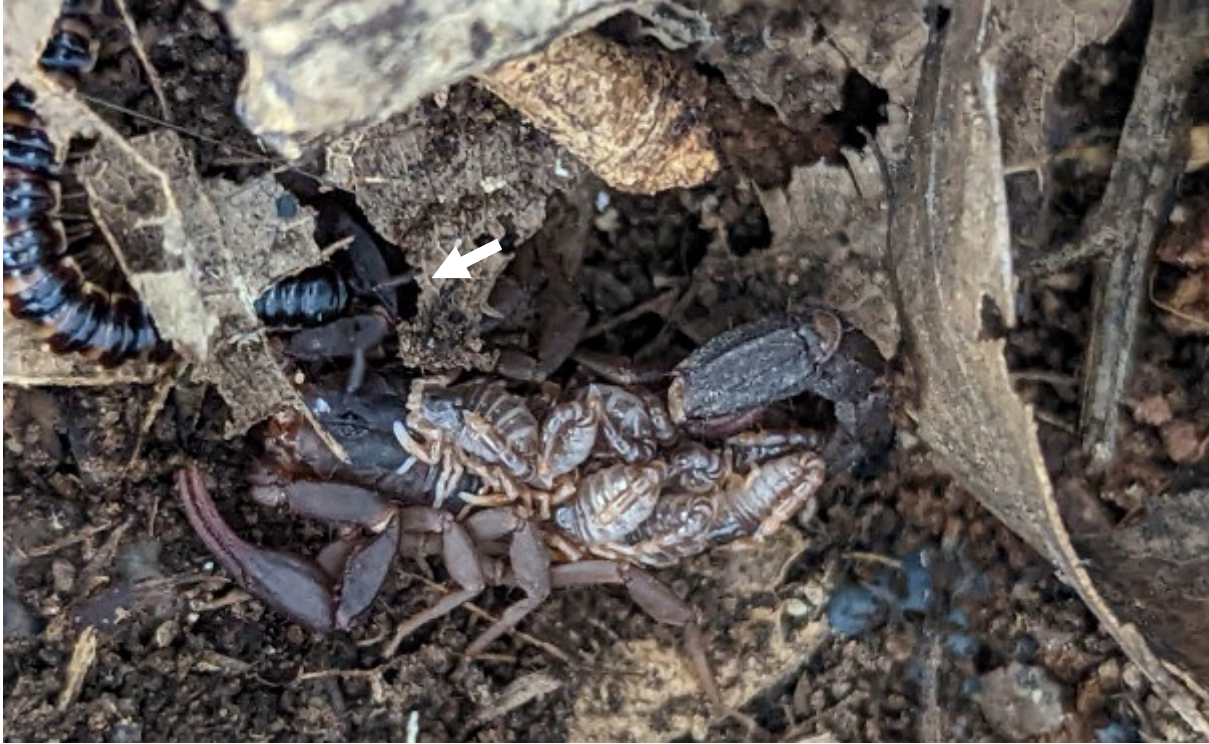
We had envisioned the scorpion acting as a potential biocontrol agent, but our dreams were dashed. It did not appear that millipedes were on her dinner menu. Look closely at Figure 17 and you'll note that a millipede rests near a joint just before the scorpion's pedipalps or pinchers.

Figure 17. The southern sun devil with young on her back. Note that a millipede rests in the joint just before her pedipalps or pinchers (arrow) leading us to believe that scorpions do not prey on millipedes.

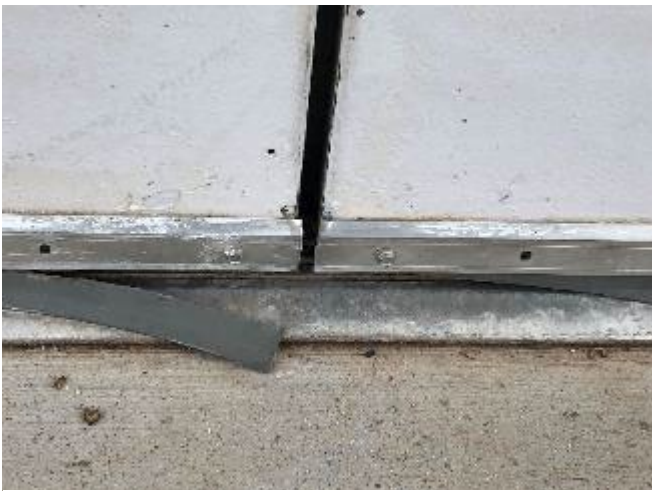
Figure 18. Damaged door sweeps and gaps between doors. Brush sweeps and astragal (brush between the doors) would seal the doors better.

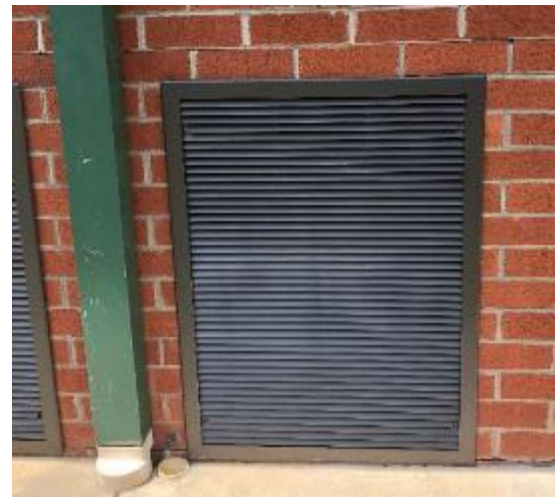
Figure 19. Each exterior room has a vent that would be difficult to screen, allow air flow and keep millipedes out.
